Texas City Manhole Rehabilitation

Texas City, TX

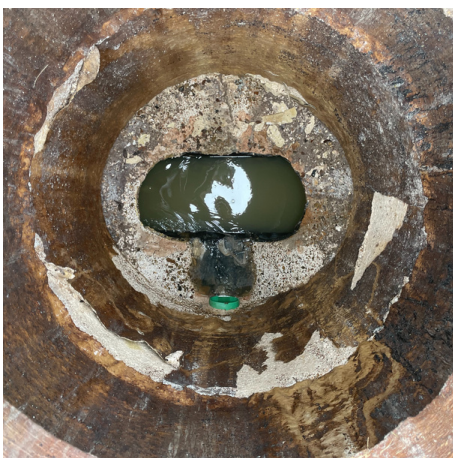
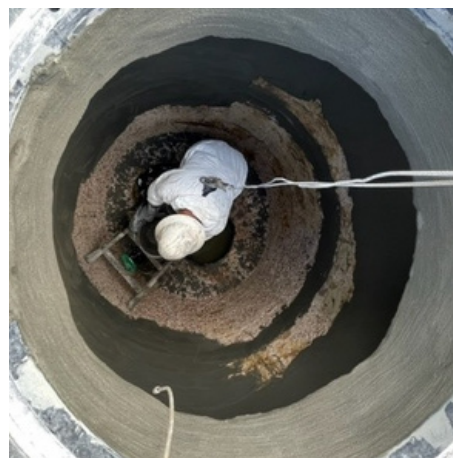
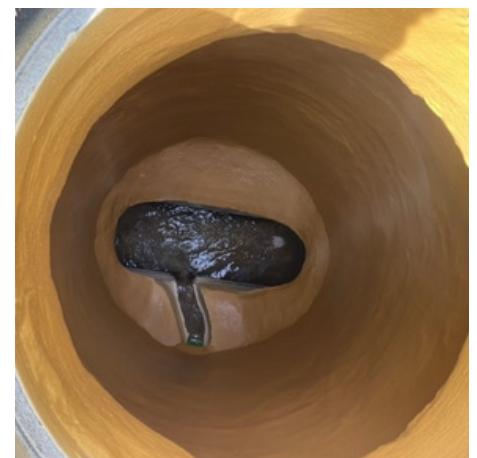
Previous coating contractors had come in to perform the work in the past, but the aggressive hydrogen sulfide gas had deteriorated the protective coating material to the point of failure.

Once the existing protective coating material had been compromised, the concrete in the manhole revealed problems in the integrity of the substrate. The catalyst for the corrosion was found in the bottom of the manhole, as the previous contractor could not coat the mainline invert due to the high-capacity flow of the 18" pipe. Prior coating products could not adequately cure before the flow was returned and bypassing was not an option.

This situation created an opportunity for gas to compromise the exposed concrete. The city was seeking a long-term solution that would not only repair what was in place but also ensure that future corrosion could be avoided.

Fuquay crews arrived on site and determined that the best solution would be to remove the failed coating, restore the concrete with Cementitious Repair Material (CRM), and apply a structurally engineered application of 250 mils of SprayWall.

A combination of cleaning and abrading the existing structure allowed for the swift extraction of the existing coating. One inch of CRM was troweled onto the aged concrete to build back the substrate to its original profile, while simultaneously filling the voids, joints, and cracks that had plagued the asset. The high-performing CRM was also used to smooth the hydraulic slide from the incoming service line to ensure a smooth transition of flow into the mainline and avoid any unnecessary turbulence.

The incoming wastewater lines were plugged to stop the flow, and the bench and invert sections were coated to the manufacturer's recommendation of 250 mils. Flow-through plugs were then used in the invert to manage the incoming flow and the remainder of the structure was coated from the bench section to the manhole ring in multiple passes to achieve the high-build requirement.
